## The solution to abnormal display after updating K518ISE

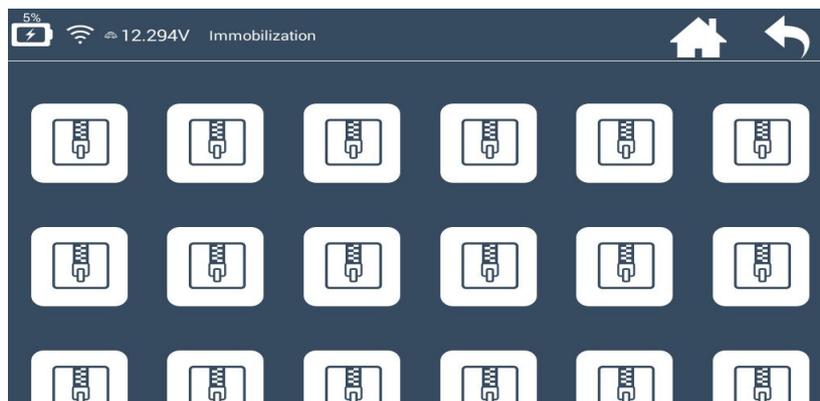
Problem: Click “Immobilizer” button after updating the device, it skips to below interface:
